# THE TRUTH ABOUT FASTENERS

# ARE FASTENER SUPPLIERS RISKING YOUR FUTURE?

## SFS INTEC DISCUSSES ACQ/CA

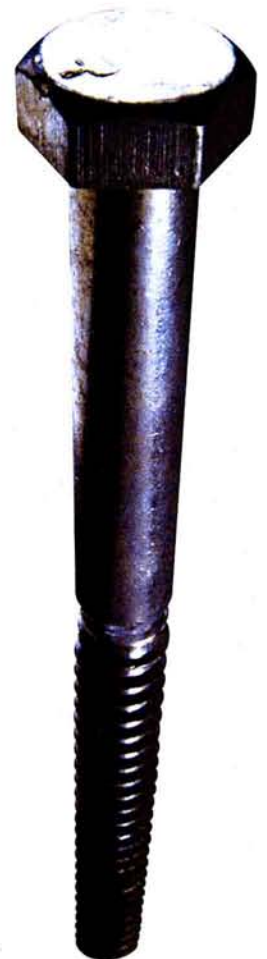
These photos show accelerated testing performed at SFS intec. In the test, screws from the same production lot were installed through steel into untreated pine and ACQ-treated lumber and then held at high humidity for 154 days.

TOP: Fastener corrosion in untreated lumber—light rust  
BOTTOM: Fastener corrosion in ACQ lumber—heavy rust and loss of threads and holding power

Certainty is available. Carbon steel, coated or otherwise, must not be used to fasten steel to ACQ/CA. Coatings, regardless of the type, get breached during installation. Steel and zinc get exposed, and the galvanic reaction begins. Stainless steel does not adversely react with the copper in ACQ/CA. Stainless-steel fasteners should be used in all treated-lumber applications to be certain the intended integrity is permanent. Steel panels can be protected through the use of a barrier, such as ice and water shield or other water-resistant, permanent membrane. These solutions may sound expensive, but when taken structure by structure, they add very little total cost and ensure the long life of a building, just as though there were no ACQ/CA problem. ■
